TESTS OF EFFECTS OF LONG DURATION BLAST-TYPE FLOWS ON FIRES IN
INTERIORS (INCLUDING EOC'S)

INTERIM TESTS OF THE EFFECTS OF LONG DURATION BLAST-TYPE FLOWS ON FIRES IN URBAN INTERIORS AND ON THE CONTENTS OF EMERGENCY OPERATING CENTERS (EOC)

C. Wilton
R. Kaplan
SCIENTIFIC SERVICE, INC.
1536 Maple Street
Redwood City, California 94063

Contract No. DAHC20-73-C-0195
DCPA Work Unit 2563A
COTR - Dr. Michael A. Pachuta

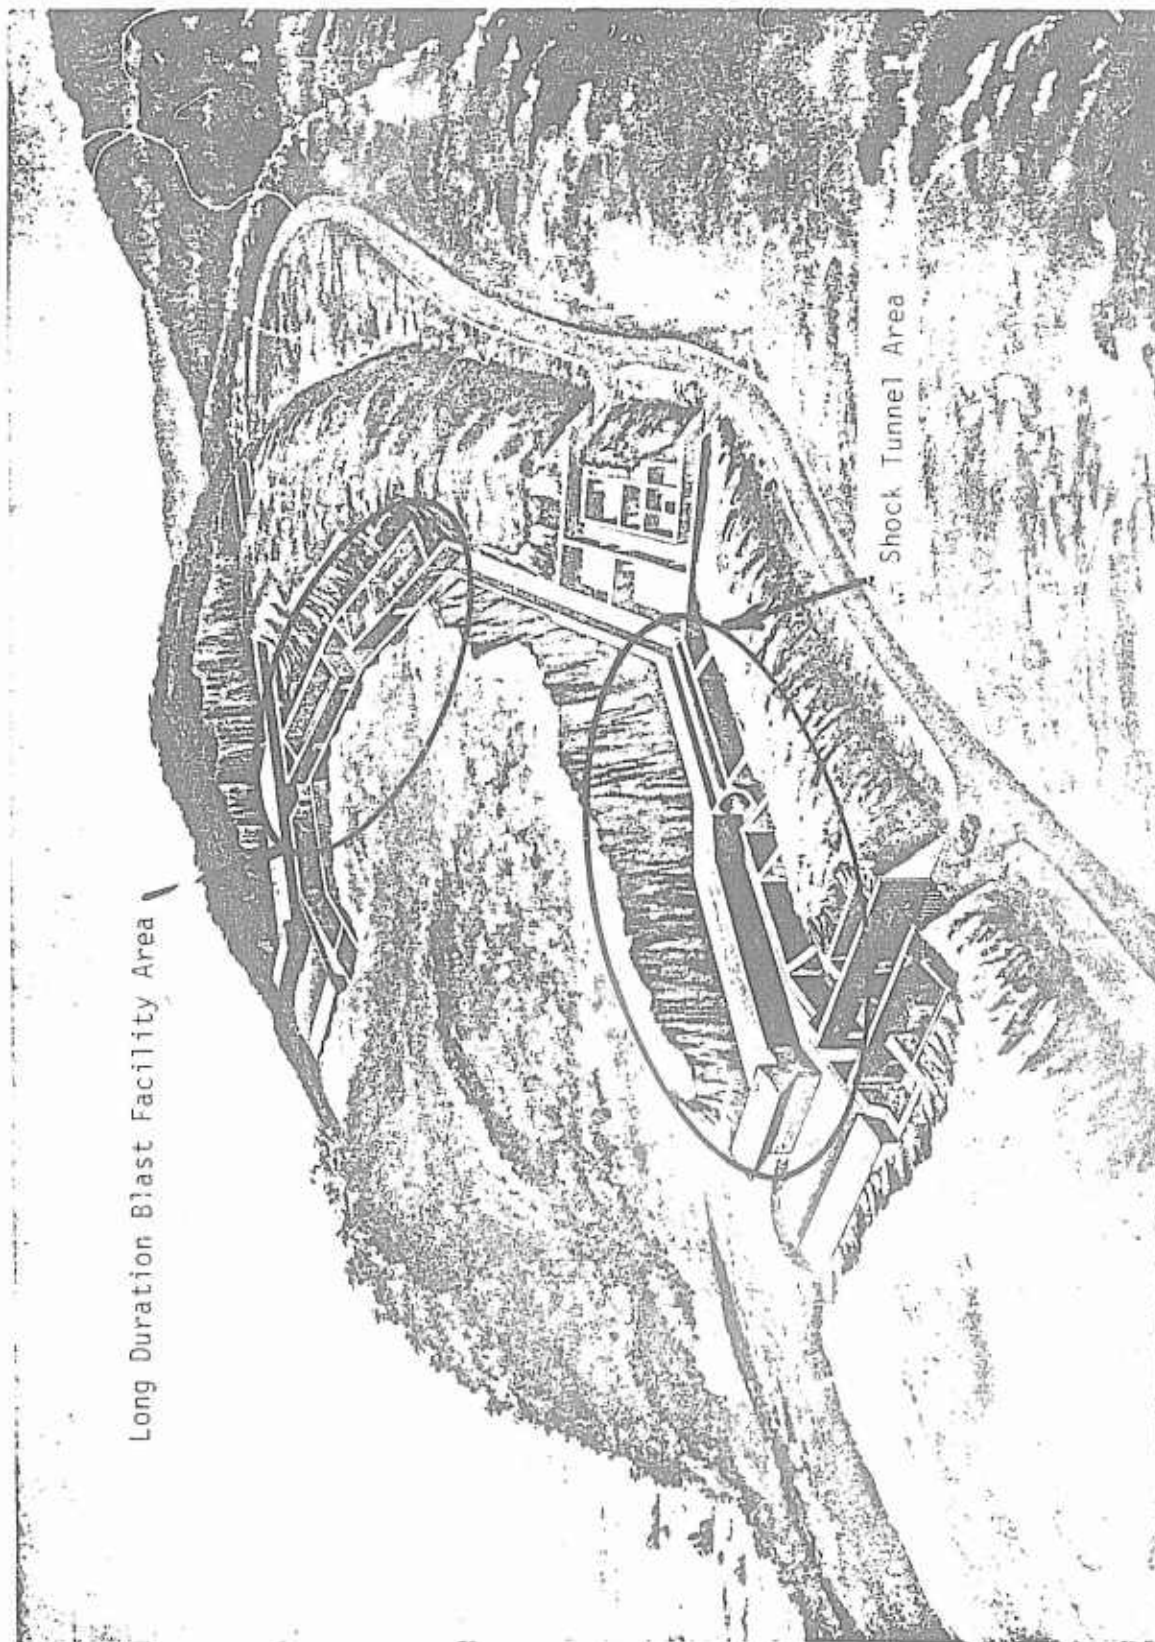
Fig. 2-1. Tunnel Complex

The underground tunnel complex which contains both the LDFF and the shock tunnel used by Goodale is sketched in Fig. 2-1. A plan view of the LDFF is shown in Fig. 2-2. A compression chamber with a volume of about 40,000 ft³ has been formed by blocking off the tunnel at Point A, and installing a wall, containing a set of heavy steel shutters at Point B. The shutters are held closed, as shown in the upper photo in Fig. 2-3, while the compression chamber is being pressurized. When the shutters are released, the compression chamber pressure forces them open, creating an opening resembling a window as shown in the lower photograph of Fig. 2-3.

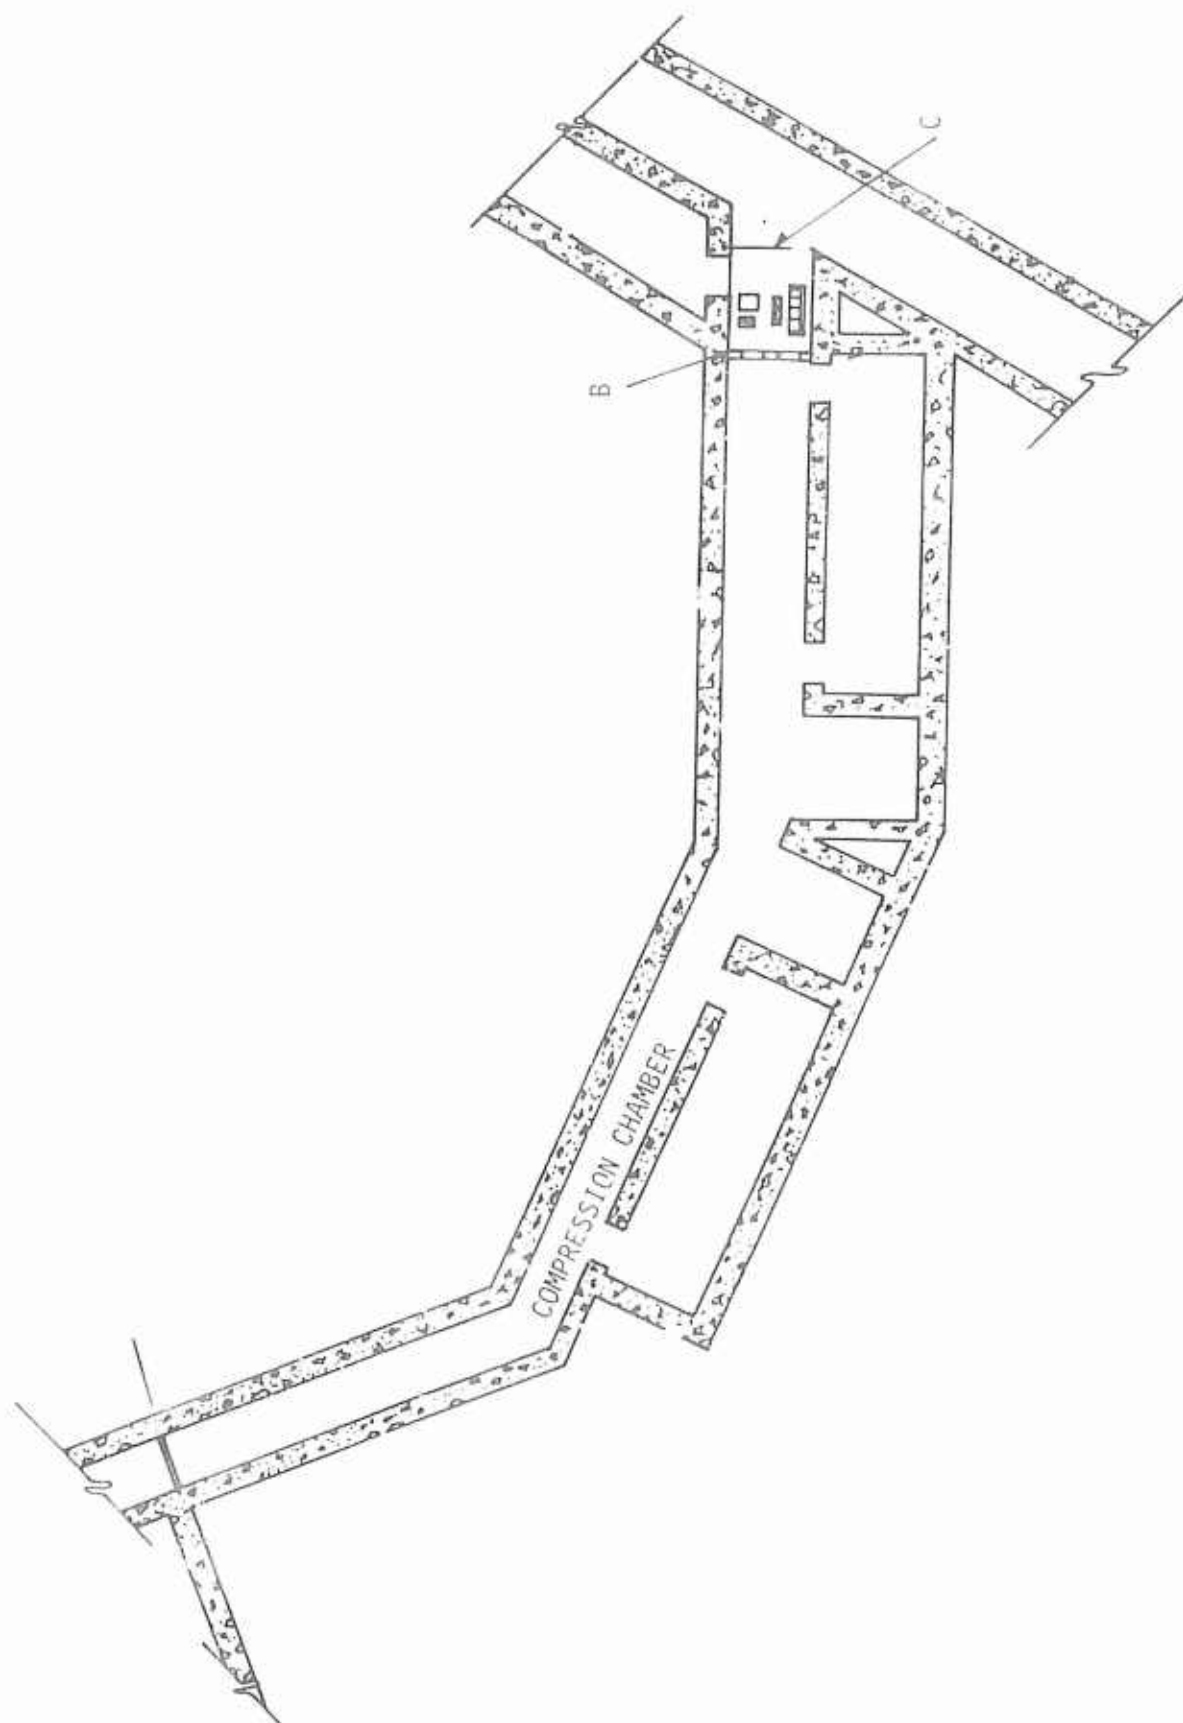
Fig. 2-2. Sketch of Long Duration Flow Tunnel Facility.

When the shutters are opened, air flows into the room through the "window" in the front wall, and begins to flow out of the room through the doorway opening in the back wall. The pressure in the compression chamber decreases as the chamber empties through the test room. This

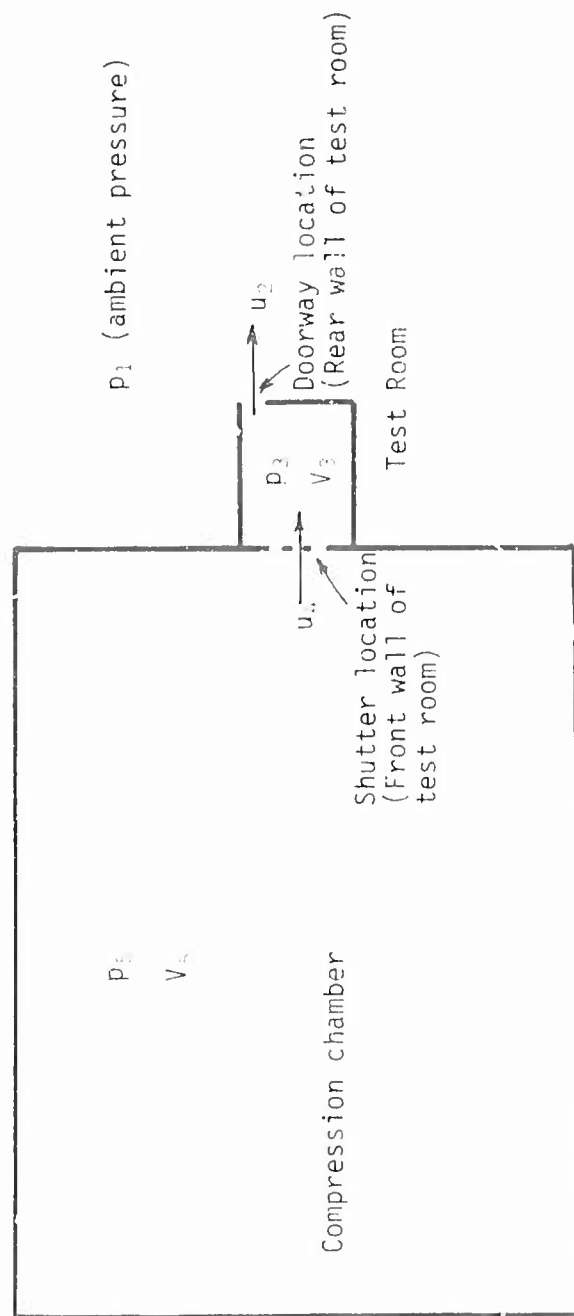
Fig. 2-4. Schematic of LDFF. p = pressure, V = volume, u = velocity. Subscript (5) refers to the compression chamber; (3) to the test room; and (1) to ambient conditions outside the facility. Subscript (4) refers to the "orifice" between the compression chamber and the test room; and (2) to the "orifice" between the test room and the outside world.

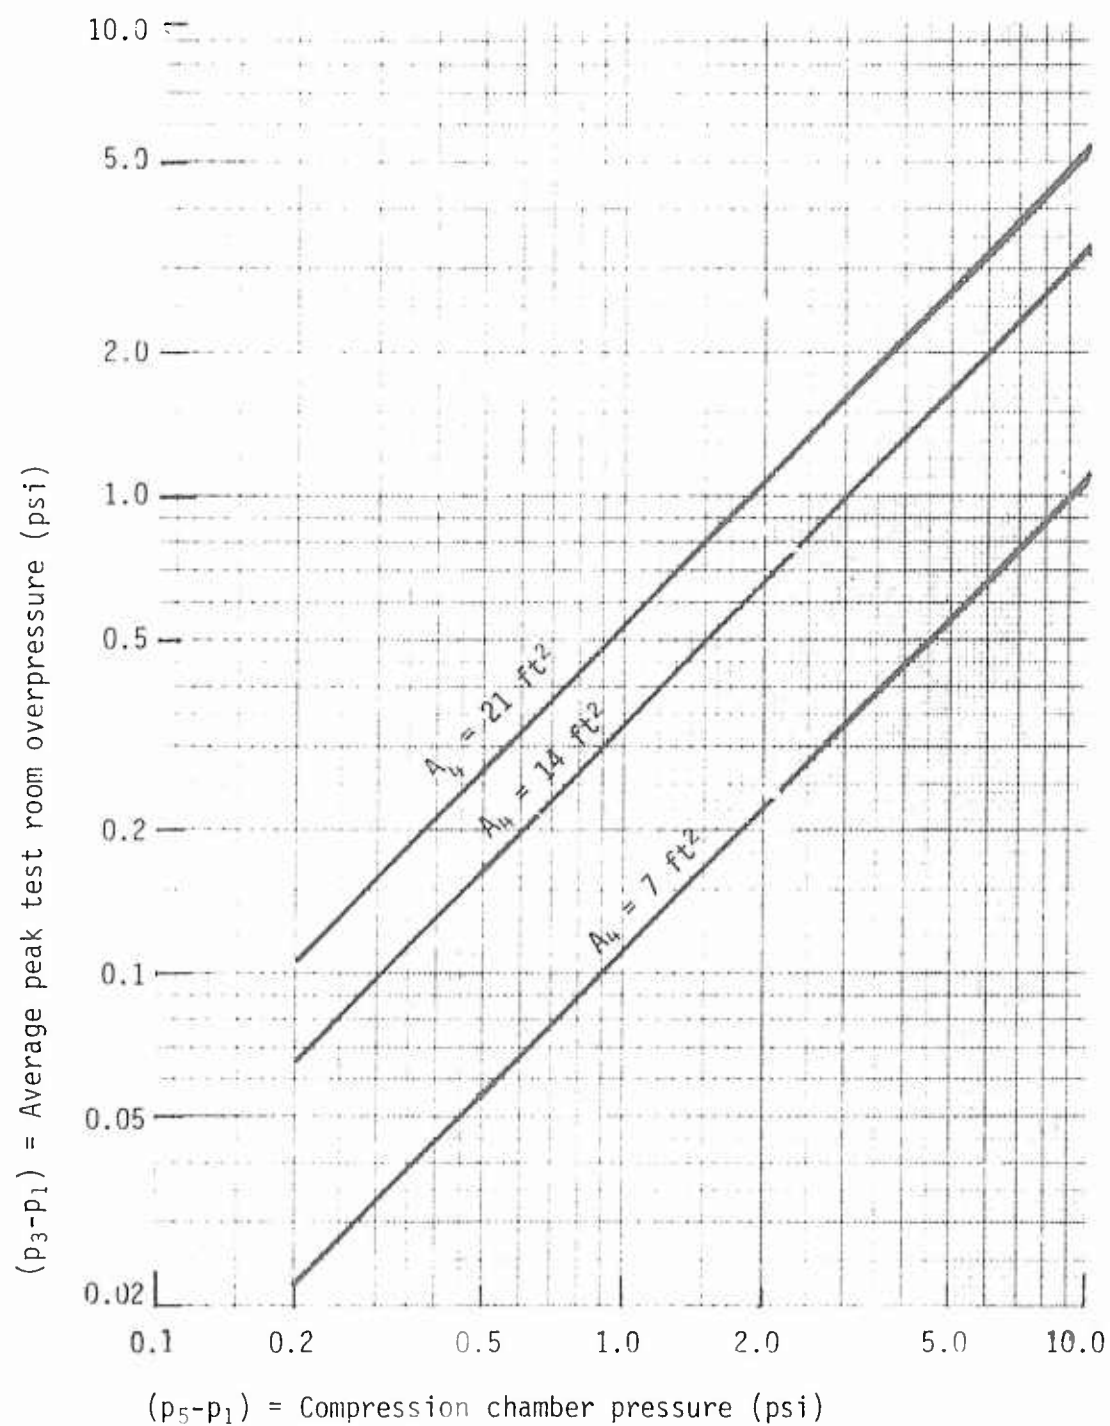
Fig. 2-5. Average Peak Test Room Overpressure, $p_3 - p_1$, as a Function of Compression Chamber Overpressure, $p_5 - p_1$, for Shutter Openings, A_u , of 7, 14, and 21 ft^2 .

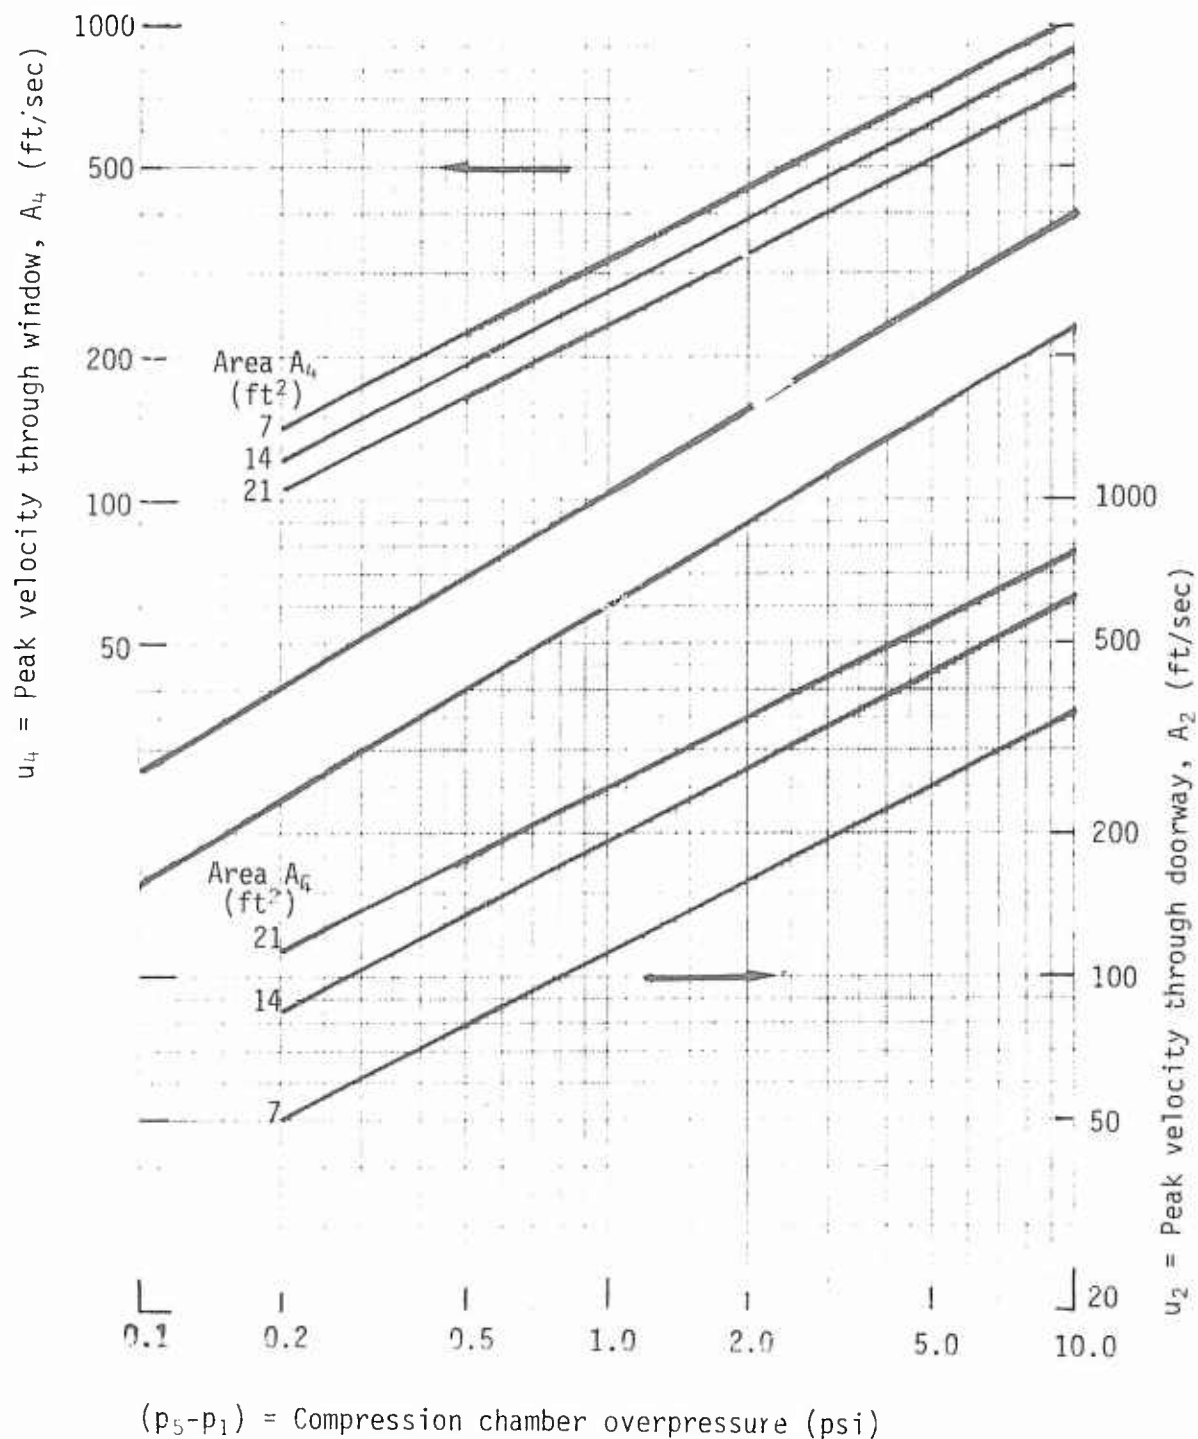
Fig. 2-6. Peak Flow Velocity, u_4 , Through Front Window, A_4 , and Peak Flow Velocity, u_2 , Through Rear Doorway, A_2 , vs. Compression Chamber Overpressure, $p_5 - p_1$, for Shutter Openings, A_4 , of 7, 14, and 21 ft^2 .

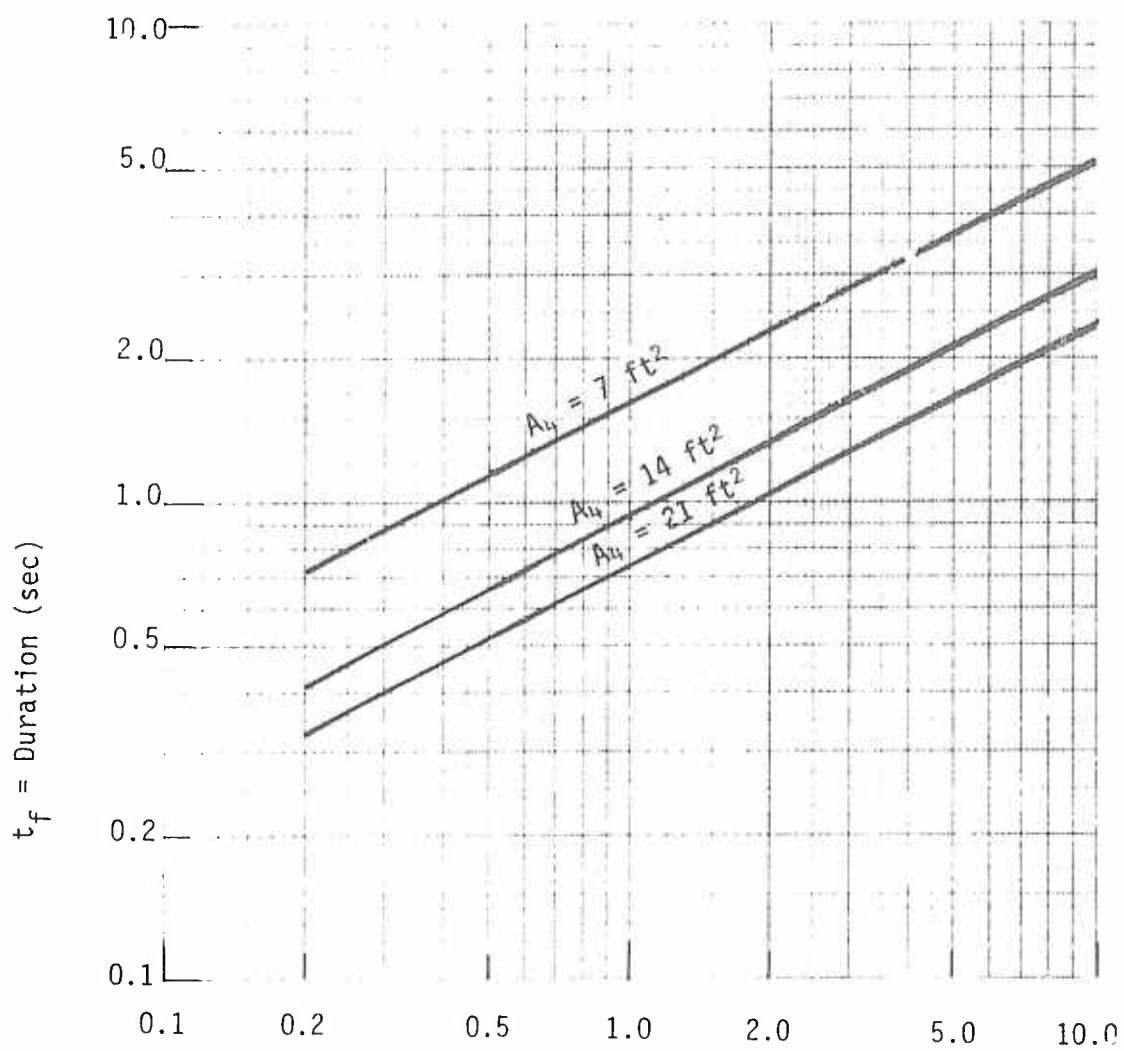
Fig. 2-7. Duration, t_f , of Flow in LDFF vs. Compression Chamber Overpressure for Shutter Openings, A_4 , of 7, 14, and 21 ft^2 .

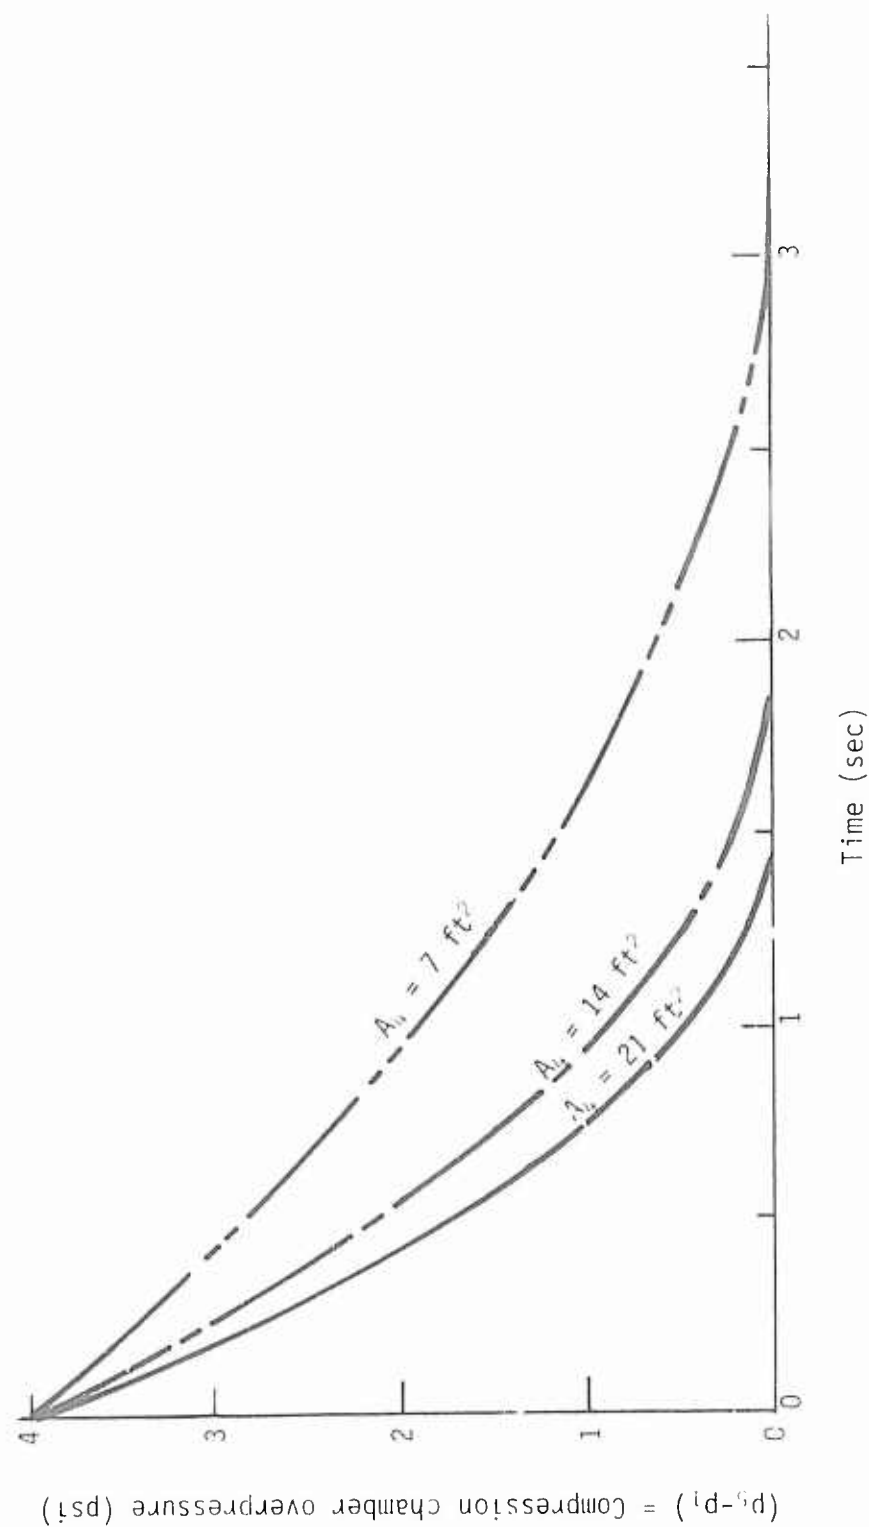
Fig. 2-8. Predicted Compression Chamber Overpressure vs. Time for Shutter Openings of 7, 14, and 21 ft^2 .

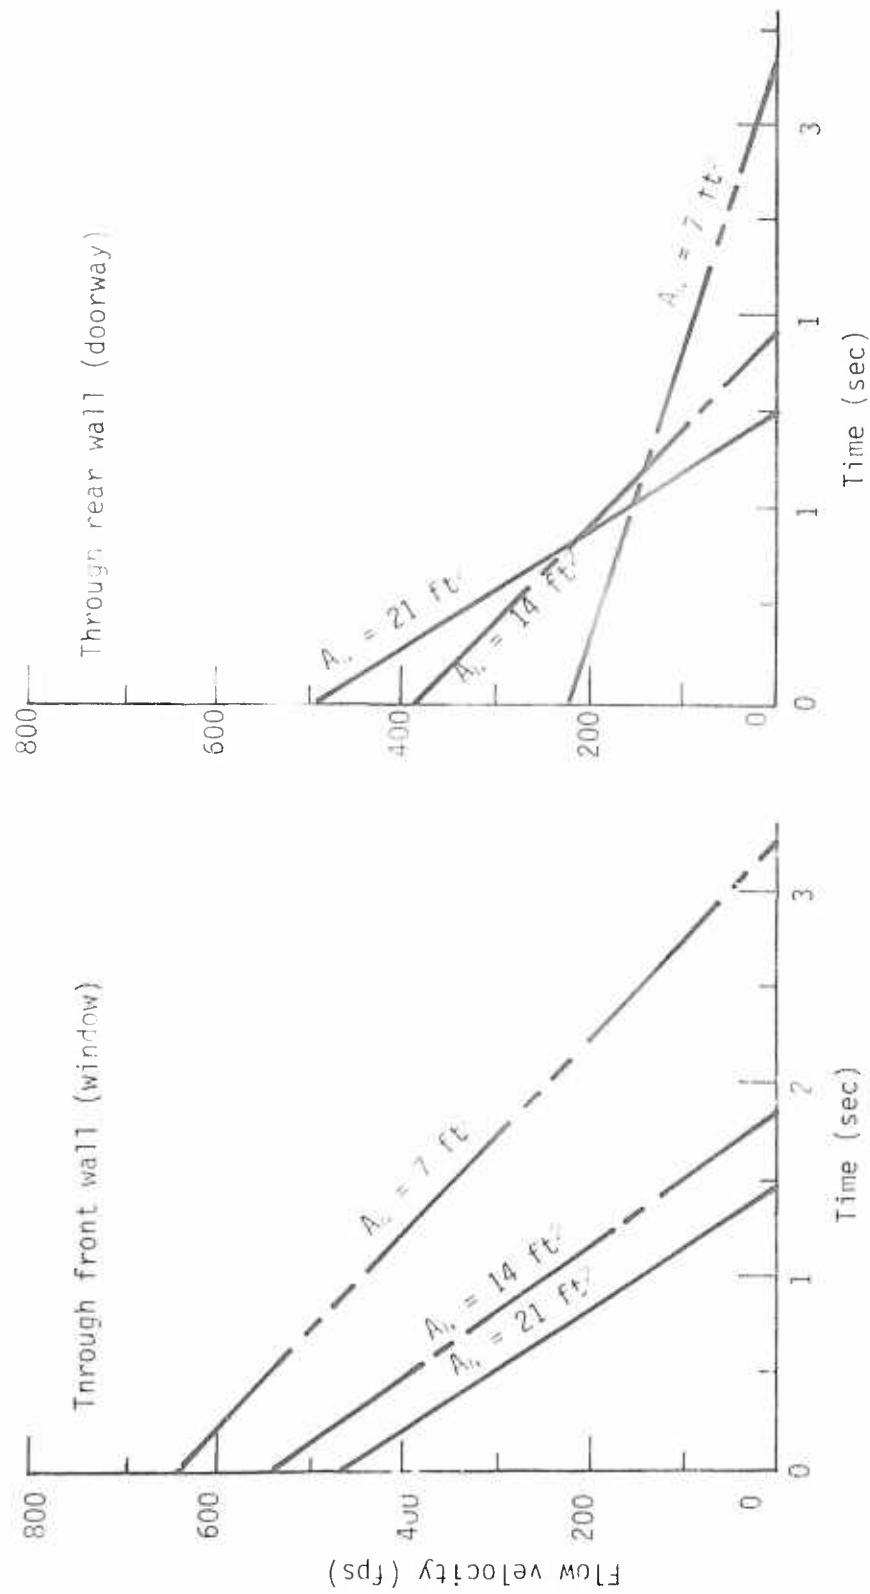
Fig. 2-9. Predicted Flow Velocities Through Front Wall (Window) and Rear Wall (Doorway) vs. Time for Shutter Openings, A_s , of 7, 14, and 21 ft^2 .

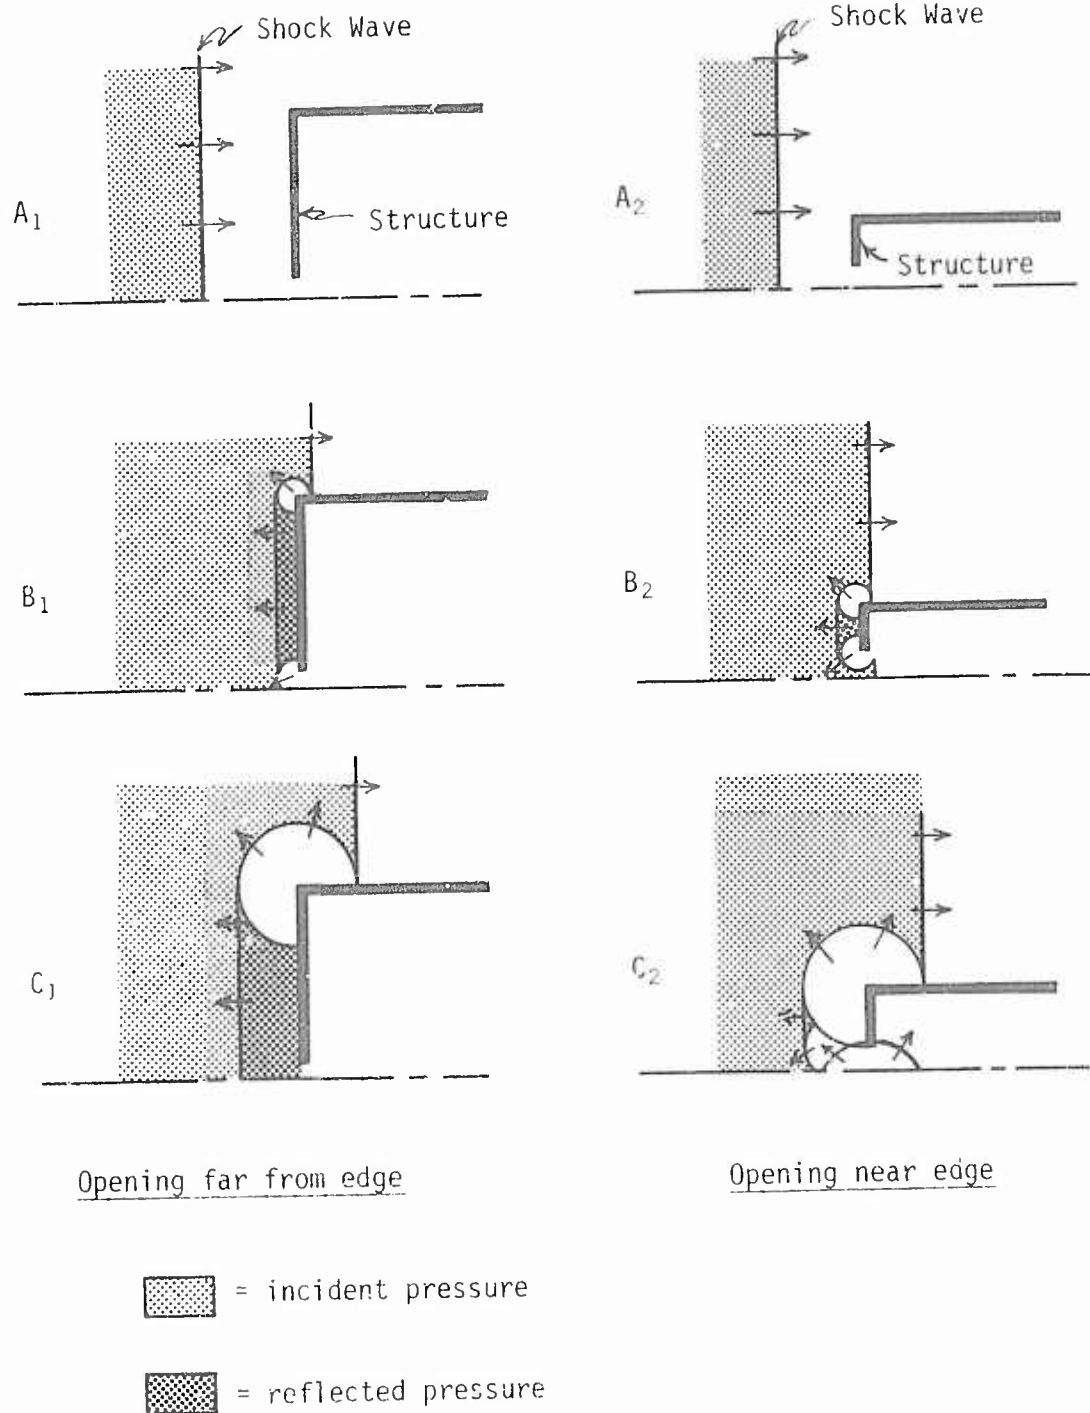
The sketches of Fig. 2-10 are highly simplified: however, conditions resembling those on the left of the figure could occur near an outside entrance to a basement in a large building. Conditions resembling those on the right could occur near an entrance to an isolated underground shelter where the entrance structure is relatively small. They could also occur near a relatively small structure, and, to some degree, near a structure whose window area occupies a significant fraction of its wall area.

The "A" sketches show conditions just before the shock wave, moving to the right, strikes the building. The light shaded area behind the shock wave indicates incident shock pressure. For simplicity, assume that the shock wave is very much longer than the building, so that pressure behind the shock front can be considered uniform.

The "B" sketches illustrate conditions just after the shock wave has struck the building. In each case, part of the wave enters the opening unchanged, and part reflects from the front wall. the dark areas in both

Fig. 2-10. Shock Wave Interactions With a Structure Containing an Opening.

The "C" sketches illustrate conditions at a later time. Note in sketch C-1 a large area near the opening is still experiencing reflected pressure, while in sketch C-2, reflected pressure still exists in only a small area, remote from the opening. Near the opening, where shock and rarefaction waves are interacting, pressure is generally above incident pressure, but closer to it than to reflected pressure.

Conditions in sketch C-1 are similar to the conditions discussed in some detail in the previous section: i.e., a pressure difference exists across an opening, and -- except in the immediate vicinity of the opening -- air on the high pressure side is largely at rest, as if it were part of a large reservoir. In sketch C-1, the high pressure is caused by reflected pressure; after clearing takes place, in both geometries, the high pressure would be caused by stagnation pressure. Such pressure differences across an opening result in flow through it as derived in Section 2.

In other words, flows through the openings shown in Fig. 2-10 change from those caused by the passage of a shock front through openings (sketches B-1 and B-2) to those more characteristic of flows through orifices driven by pressure differentials across them.

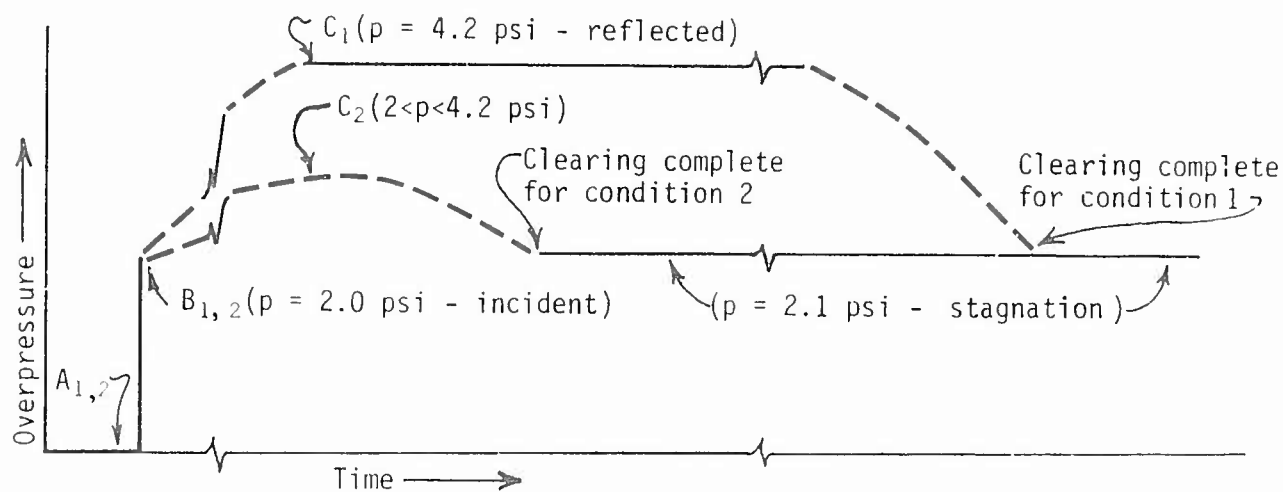
Fig. 2-11. Overpressure Outside Openings in Buildings Struck by Very Long Duration Blast Waves. Letters and numbers correspond to those in Fig. 2-10.

types of structures struck head-on by a long duration blast wave. The pressures rise from zero and stabilize. Fig. 2-12 shows that flow through an opening into a large downstream volume changes from shock induced flow to that induced by pressure differentials across the opening. (As just noted, the constant pressure portions of Fig. 2-11 should be modified by superimposing pressure decreases derived from Eq. 2-14.)

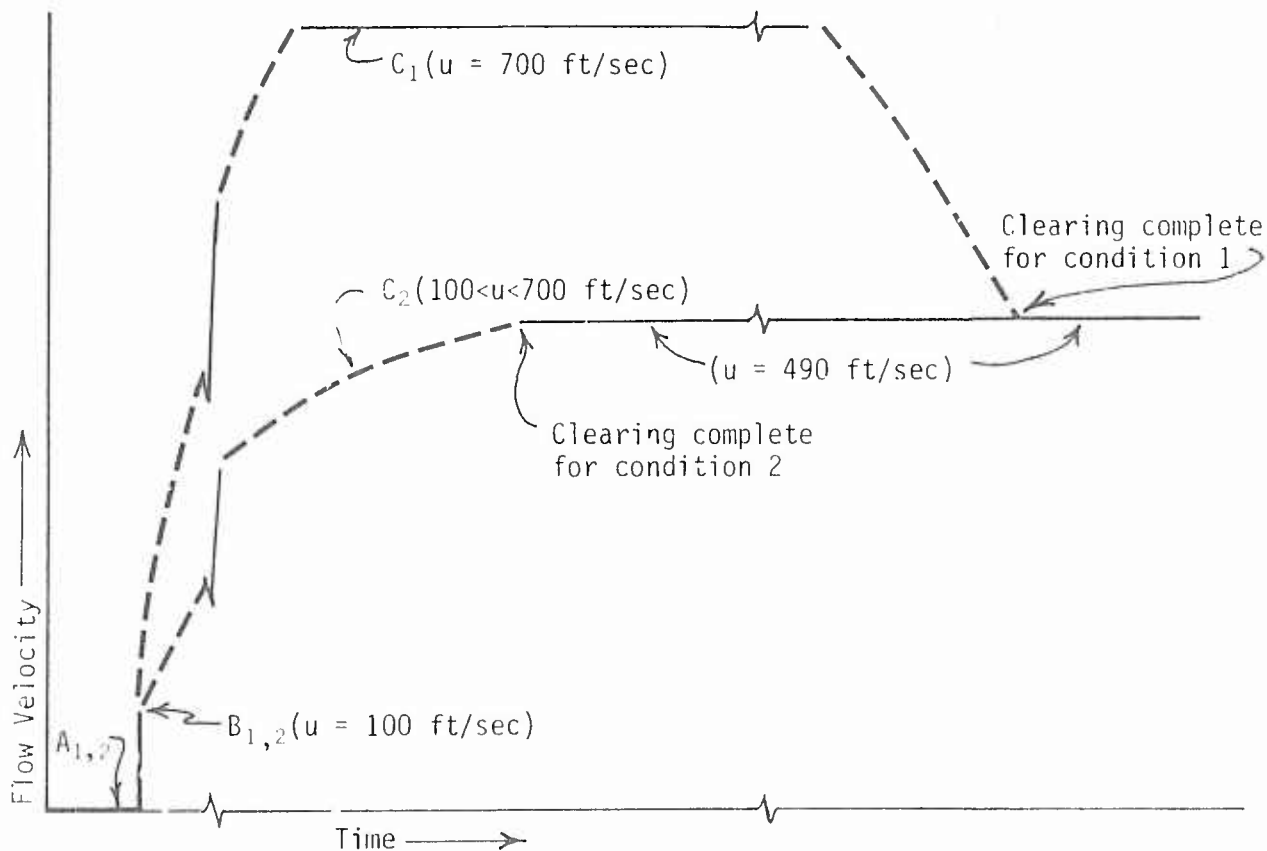
Fig. 2-12. Flow Velocities Through Openings in Buildings Struck by Very Long Duration Blast Waves. Letters and numbers correspond to those in Fig. 2-10.

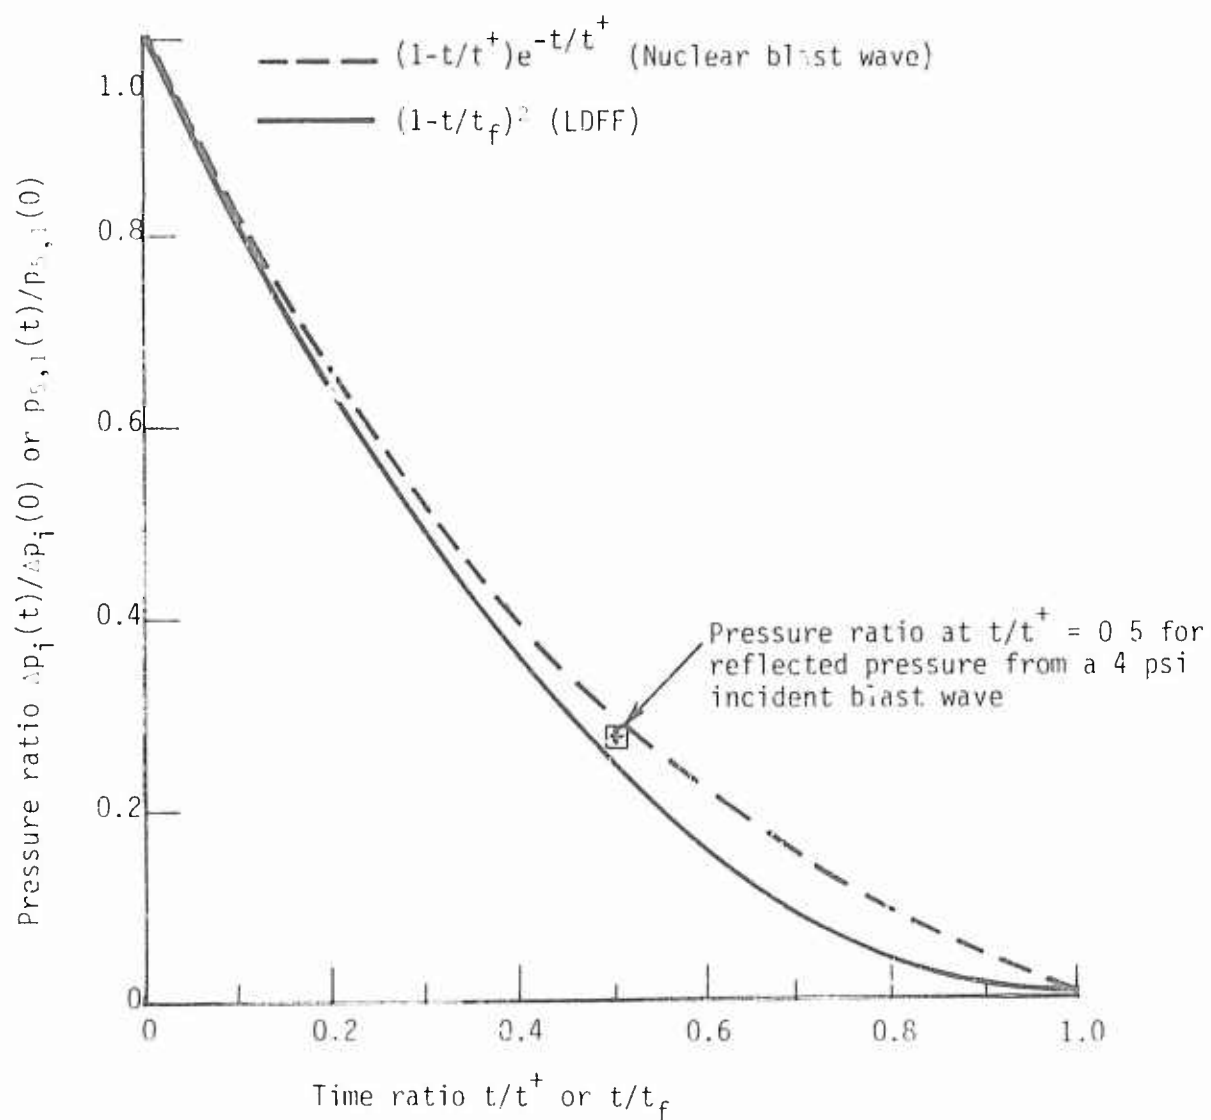
Fig. 2-13. Comparison of Nuclear Blast Wave with LDFD Chamber Pressure Fall-Off With Time.

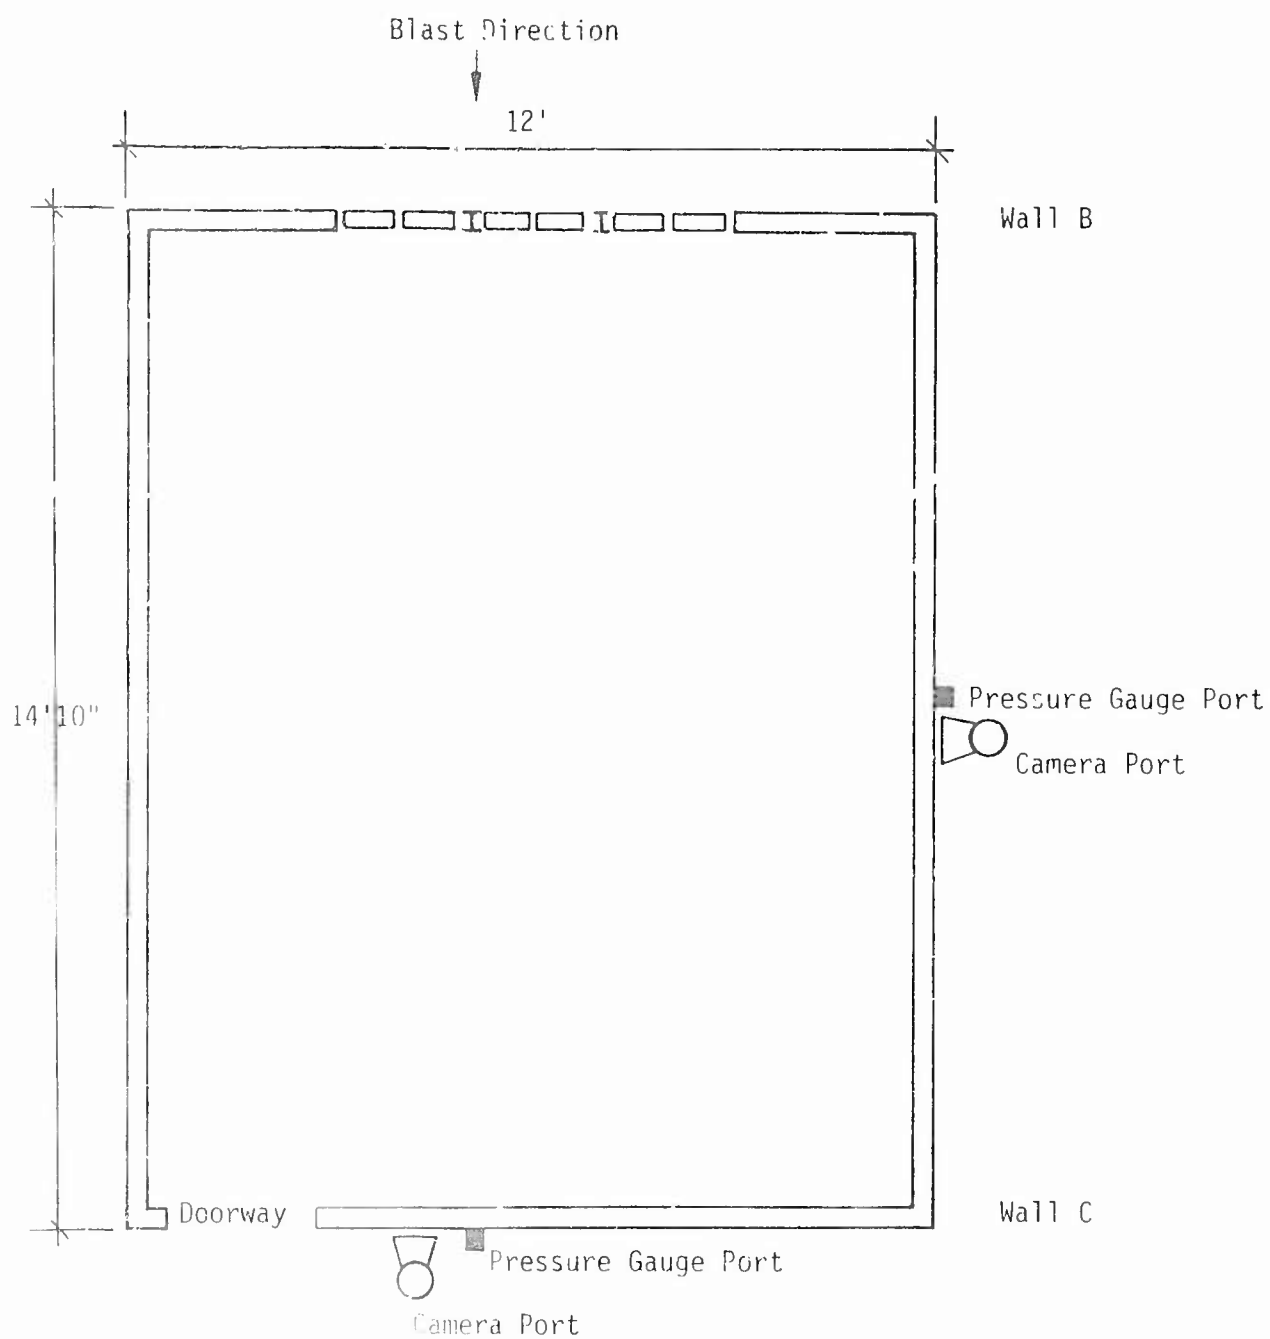
Fig. 3-1. Sketch of Room Geometry.

twenty to sixty seconds. After a time delay equivalent to the delay between the arrival of the thermal and blast pulses from bursts of low megaton range weapons, the shutters were opened. Subsequent phenomena in the room were photographed with the two high speed cameras, one located at the rear of the room and pointed toward the shutters, and a second located in the side wall furthest from the doorway and pointed across the room. A Tyco (strain gauge type) pressure gauge was located on the side wall near the camera port, and a Kistler (piezoelectric) pressure gauge was located in the center of the solid portion of the rear wall. A leaf switch was located near the doorway, and for certain tests, an anemometer was placed in various places in the room. Camera port and gauge locations are shown on Fig. 3-1.

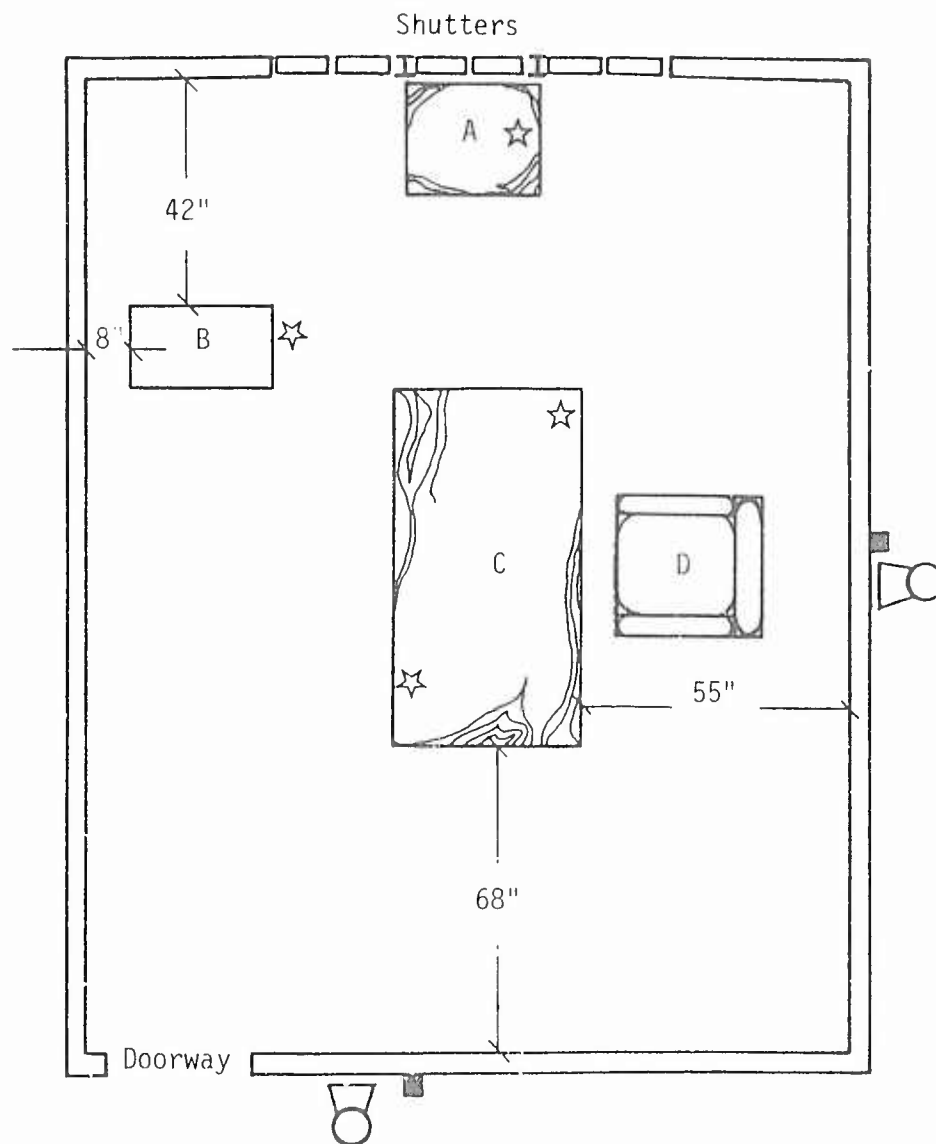
Fig. 3-2. Sketch of Test Geometry, Test Number 3

- A - 24 x 22 in. table with books
- B - 26 x 14 in. four drawer file cabinet
- C - 34 x 60 in. wood desk
- D - chair with steel frame and plastic cushions
- ☆ Ignition sources

Four tests (Numbers 1 through 4) were conducted with the office geometry shown in Fig. 3-2. Before the tests, papers were scattered about on the desk and in the drawers of the filing cabinet, as shown in Fig. 3-3, and books were placed on the book table. The combustible materials were ignited with ignition sources such as those shown in Fig. 3-3.

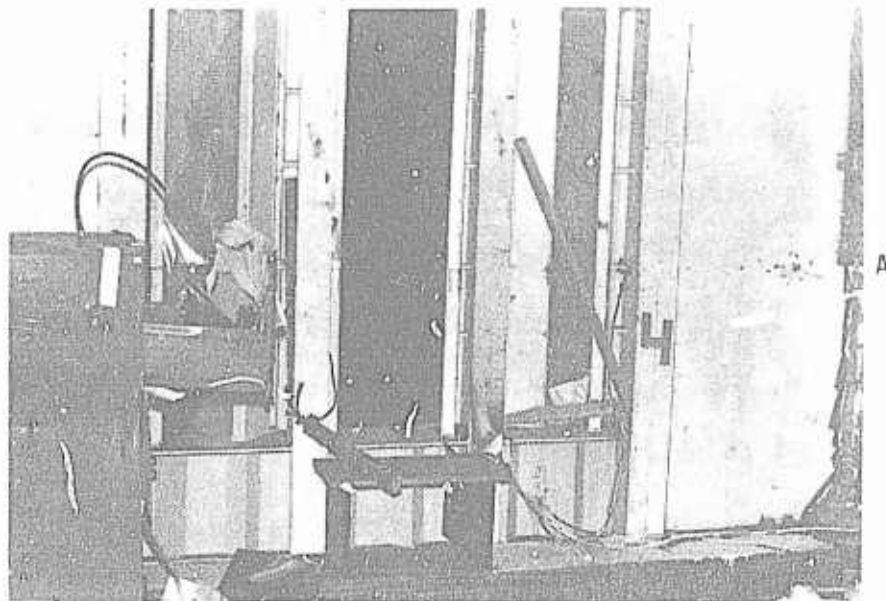
Fig. 3-4. Posttest Photographs, Test Number 4.

In all cases, all fires were extinguished. Considerable rearrangement and breakage of the furniture took place, more with the 14 ft² opening than with the 21 ft² opening, see Fig. 3-4. Some papers were ejected from the room.

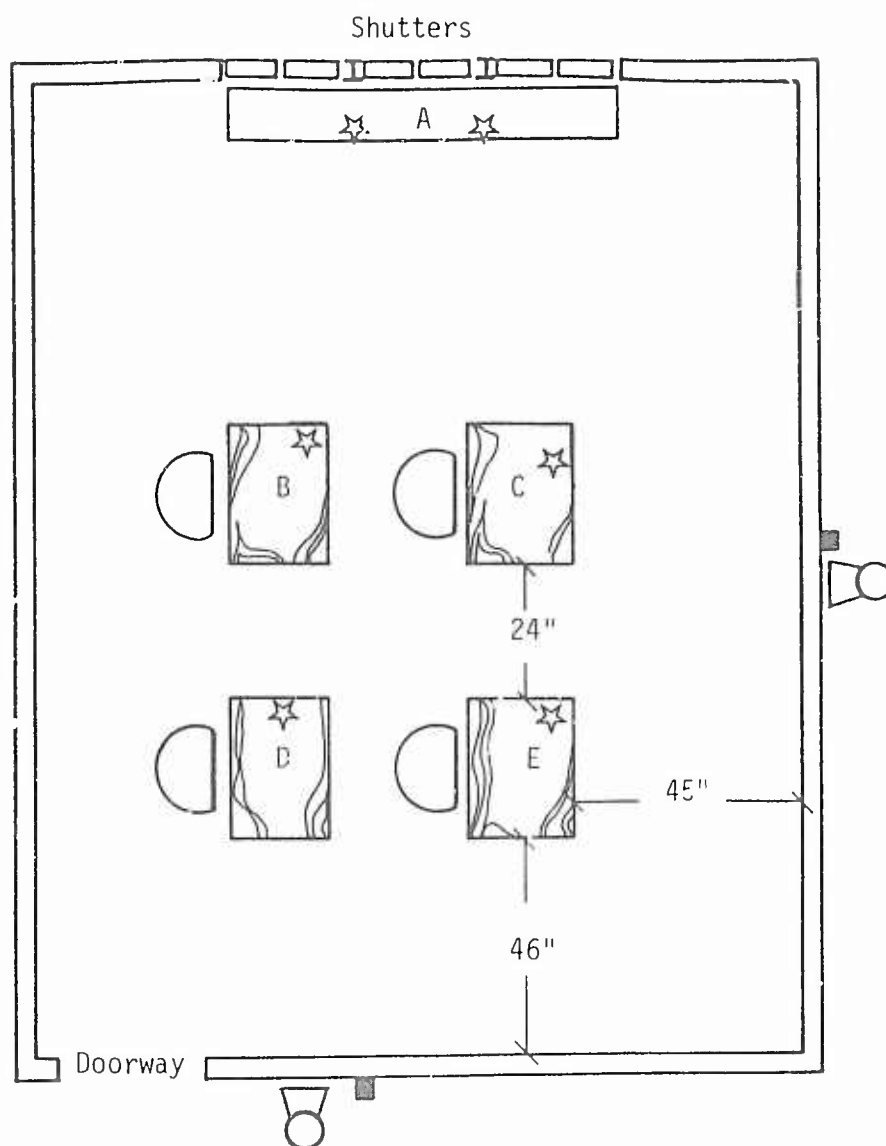
Fig. 3-5. Sketch of Test Geometry, Test Number 5

A - 12 x 60 in. shelf

In both cases, all fires were extinguished. One desk tipped over on Test 5, none on Test 12. The desks that did not tip over were moved, but not a great deal, (see Fig. 3-i).
